Ecosystem Services Science,
Policy and Practice in the
face of Global Changes

LYON CITY DEMO SITE

Blue – Green Infrastructure

General presentation of NBS demonstration sites in the Yzeron basin (France)

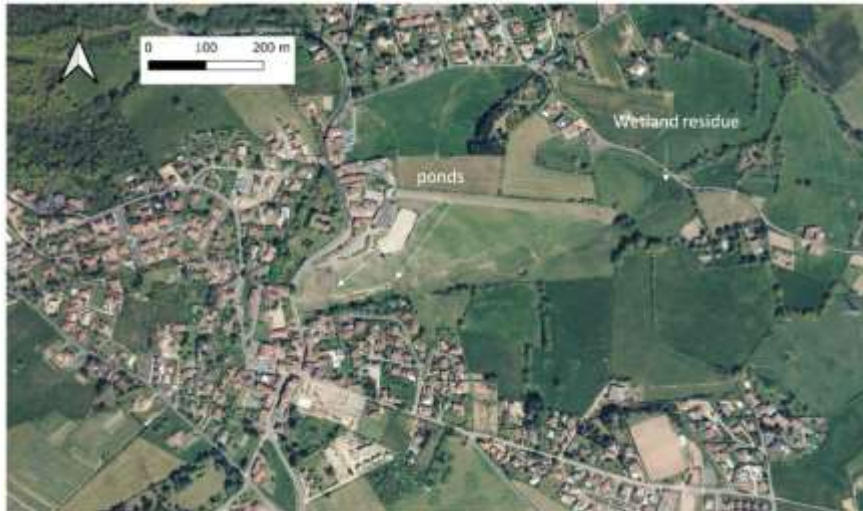
DEMOSITE 1

Problem to solve:

Current situation with a very degraded combined sewer pipe, which runs from the village to the lift station. This causes drainage of the wetland area crossed and frequent overflowing of the lift station into the natural environment.

NBS solution under study:

construction of a treatment plant based on a filter planted with reeds. Replacement of the degraded network with a new wastewater network, which involves separating rainwater from wastewater from the village. Choice of the location of the planted filter to avoid its flooding and preserve the wetland.

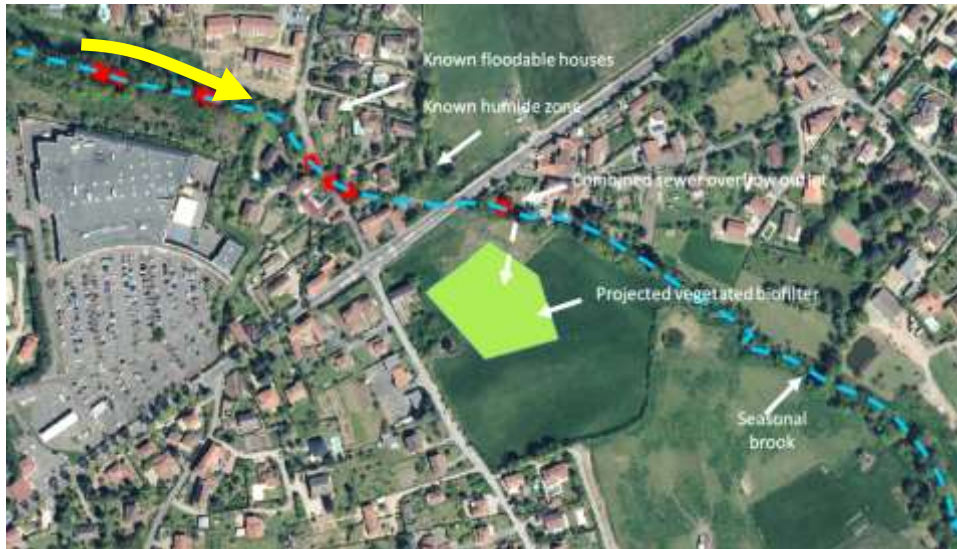
DEMOSITE 2

Diagnosis of runoff paths :

Modelling of intense runoff shows that there is no opportunity for gravity accumulation on the left bank. On the other hand, an accumulation process (blue) exists in the watercourse downstream of an erosion zone (light green).

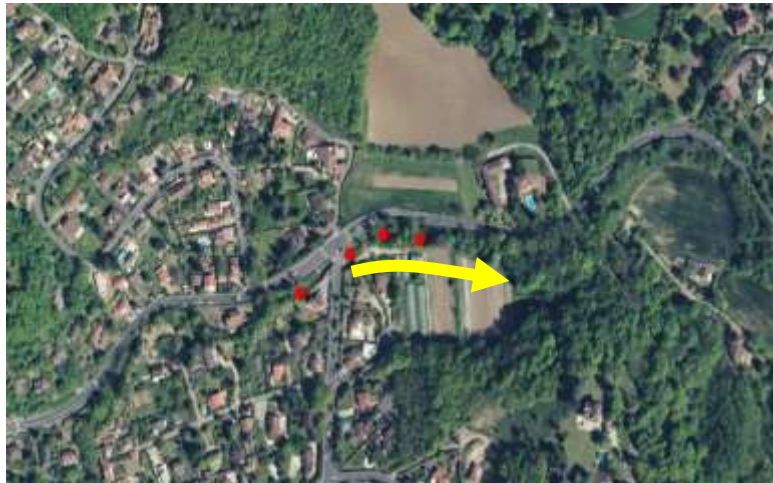
DEMOSITE 3

Diagnosis of runoff paths :

Modelling of intense runoff shows that there is no opportunity for gravity accumulation on the left bank. On the other hand, an accumulation process (blue) exists in the watercourse downstream of an erosion zone (light green).

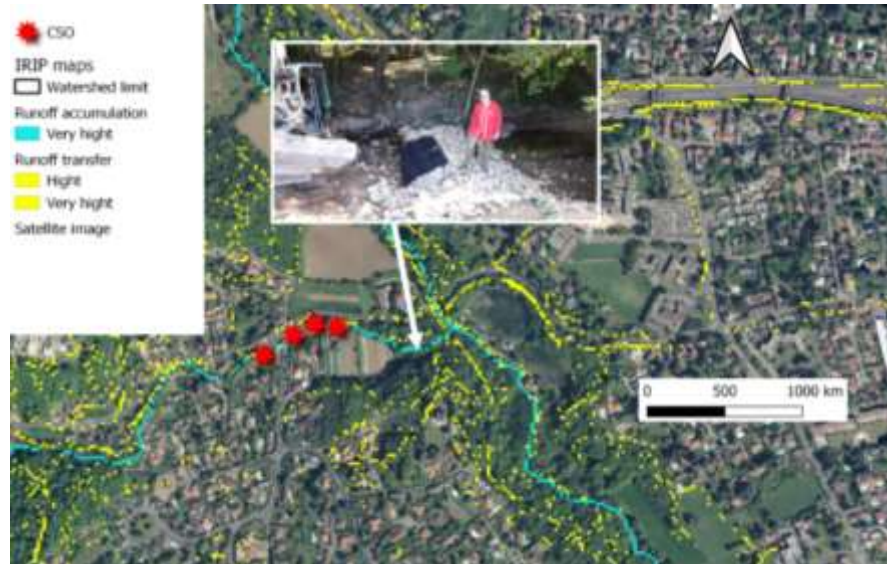
NBS solution under study:

A solution to amplify the self-purification capacity of the river was completed in September 2020. This consists of locally modifying the topography of the watercourse to promote the creation of hyporheic biofilters. A topographical study of the bed of the watercourse as well as a hydraulic study made it possible to specify the locations of devices called porous ramps.

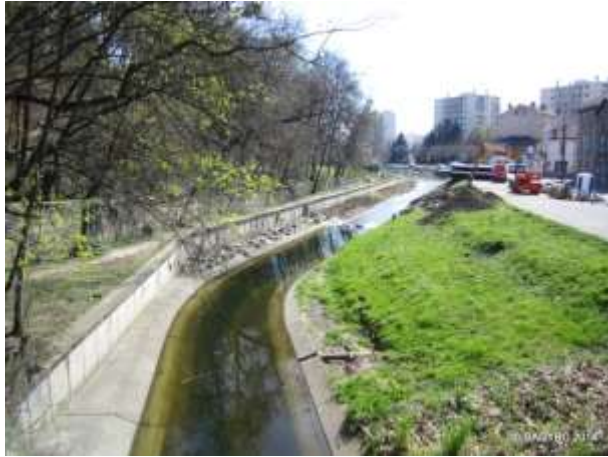
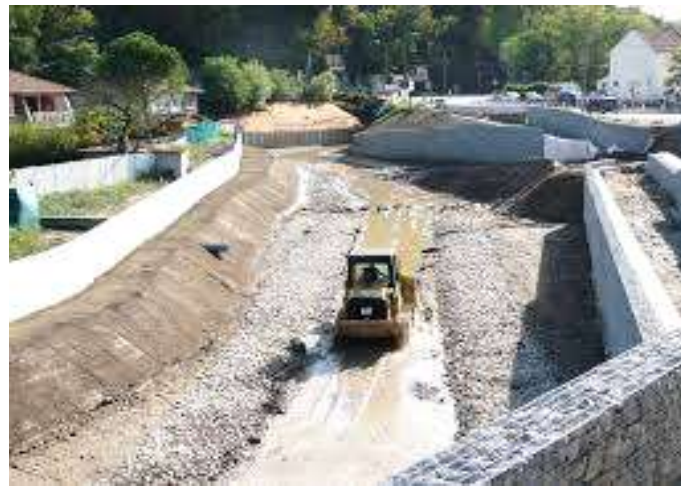
DEMOSITE 4

Diagnosis :

The concrete bed, developed over 2 kilometers, has disconnected the river from its groundwater table and prevents the deposition of sediments. This prevents the self-purification process from working in an area that receives a lot of discharges from stormwater spillways that are loaded with organic matter.

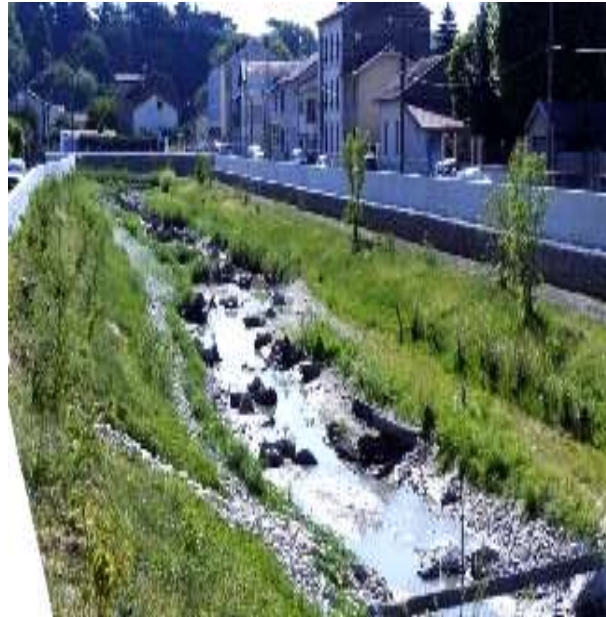
Adopted NBS solution :

The water neck has been widened and redesigned. The connection between the river and the groundwater has been restored, allowing the self-purification process in the hyporheic zone to function properly. The banks have been consolidated by biodegradable geotextiles. Native plants and trees were planted to recreate a diversity of terrestrial habitats. Roots will be used to ensure the long-term stability of the banks. Pebbles and large boulders were used to create a stabilized hydraulic diversity in the stream. A footpath has been built to allow public access. However, night lighting was prohibited to allow nocturnal species to move about. Garbage cans have been banned as they are taken away during the flooding of the watercourse. This poses a problem of cleanliness of the site which is very busy.

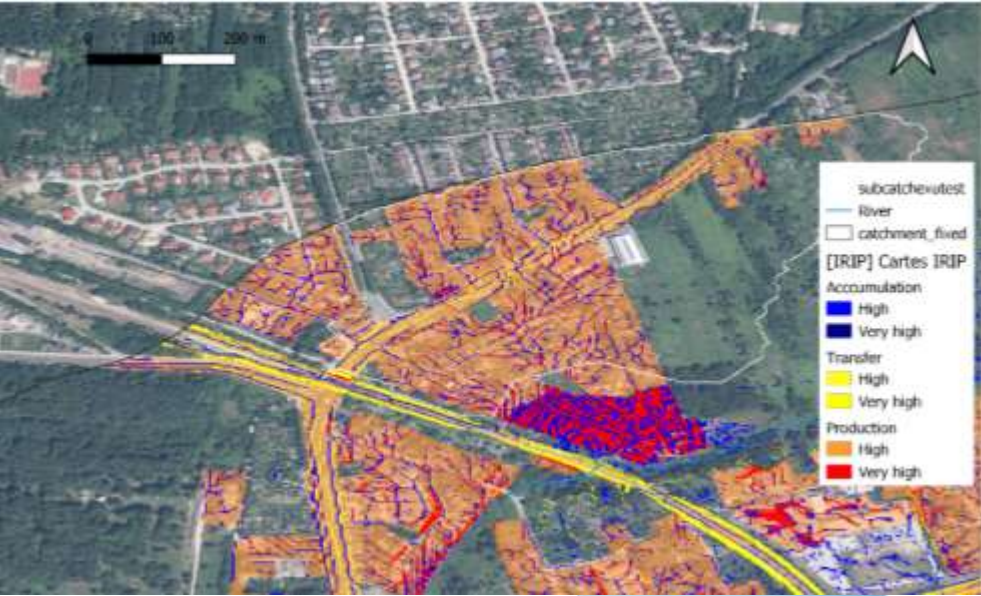
Scientific: WP2 / D1.1. Irip model implementation in selected catchments in each partners' country

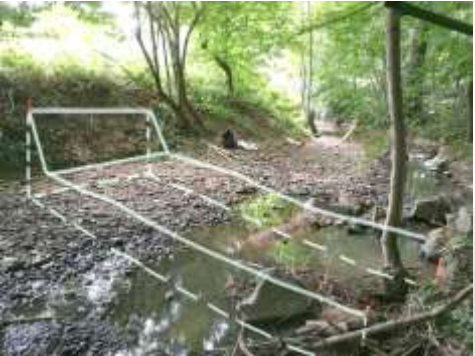
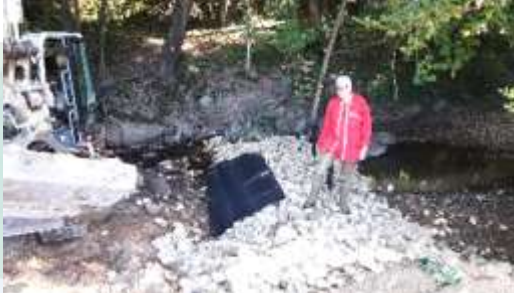
Technical: WP2 / D2.2. design, implementation, construction of a new NBS in the french demosite.

Principle of constructed porous ramps (P. Breil & Ph. Namour)
